GLOBAL TIRE MANUFACTURER MANAGED RELIABILITY PROGRAM

OIL ANALYSIS AND SIDE STREAM FILTRATION

Case Study

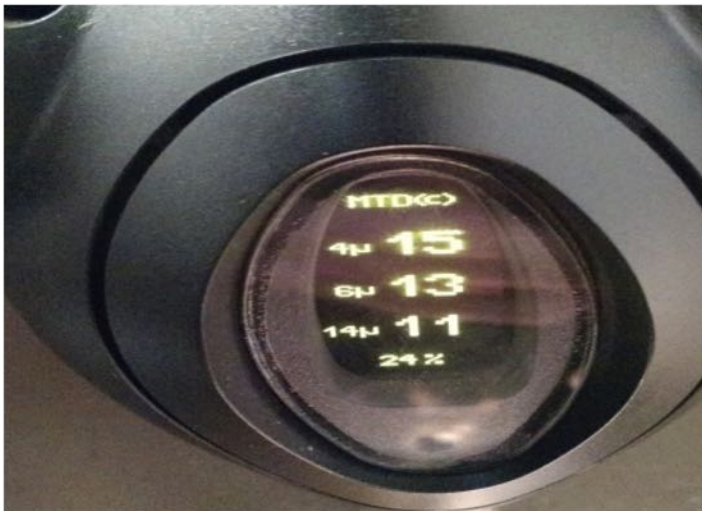
An inline laser particle counter provided real-time oil analysis

emulsified and dissolved water. It was then filtered to remove particulates in order to exceed the target ISO code of 17-15-11. An inline laser particle counter and a moisture reader verified the oil health and ISO cleanliness level as the it was pumped into the clean oil holding tanks for reuse. The holding tank was spot checked every month to ensure fluid cleanliness from a 3rd party laboratory.

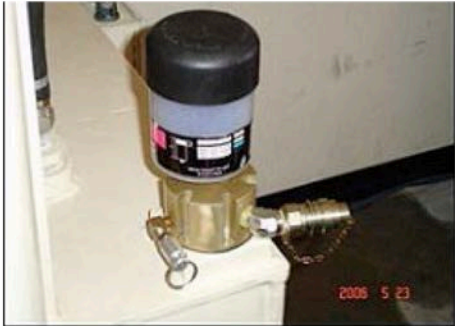
Each reservoir was outfitted with a RIG BSF (Breath/Sampler/Filler) to prevent moisture accumulation while allowing the system to breath as well as provide a consistent sample and connection point for the filter cart. The BSF kits also provided the added benefit reducing opportunities for contamination by eliminating the need to open the reservoir for sampling or filtering.

Figure 1. BSF kit installed on a hydraulic oil reservoir

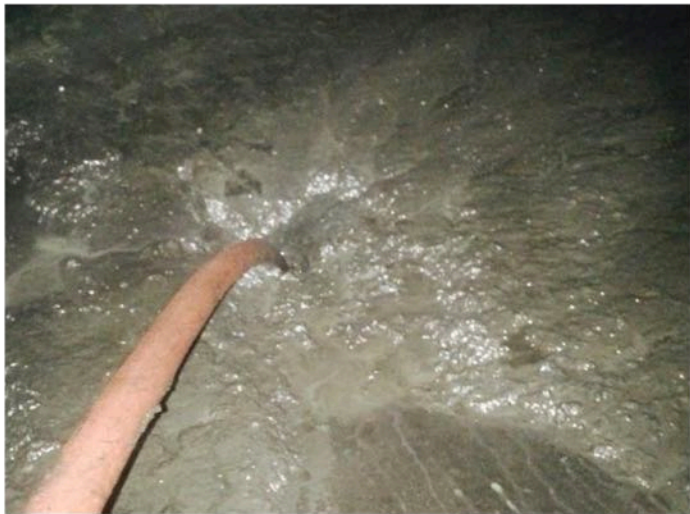
Figure 2. Oil reservoir prior to annual cleaning

The final component of the ISO cleanliness program was annual cleanings of each hydraulic reservoir. To ensure that each system was free of any dirt and debris RIG would clean each systems reservoir every year. During a shutdown period RIG’s confined space certified personnel would drain the reservoir, clean the reservoir, inspect/replace suction strainer, replace all filter, and inspect/replace reservoir access gasket. By cleaning the reservoirs every year we were able to ensure that any of the build up on the tank walls and bottom of the tank were not transferred into the hydraulic system.

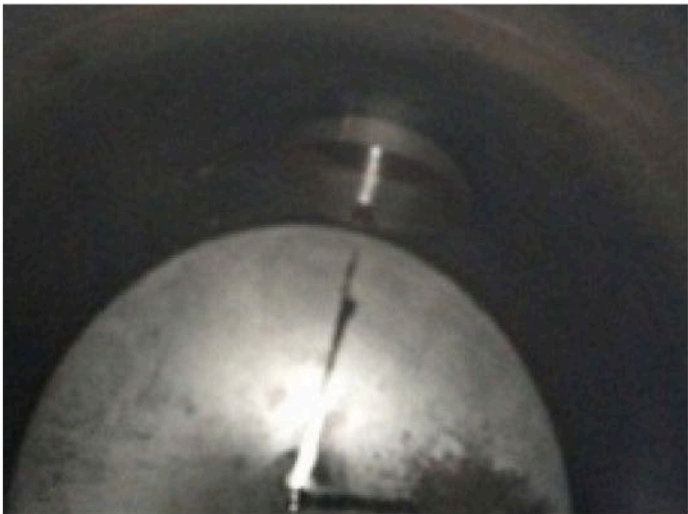
Figure 3. Clean oil reservoir after annual cleaning
